Fault assessment of disc brake pads and brake discs

Technical Information

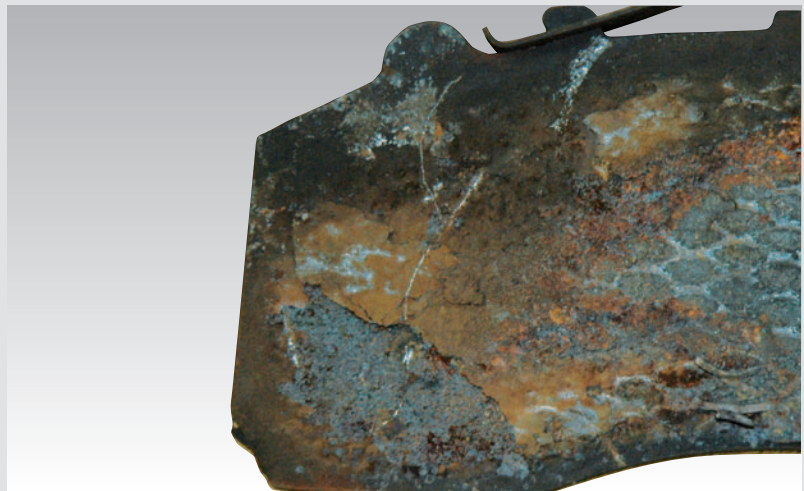
► Heavy underlying corrosion

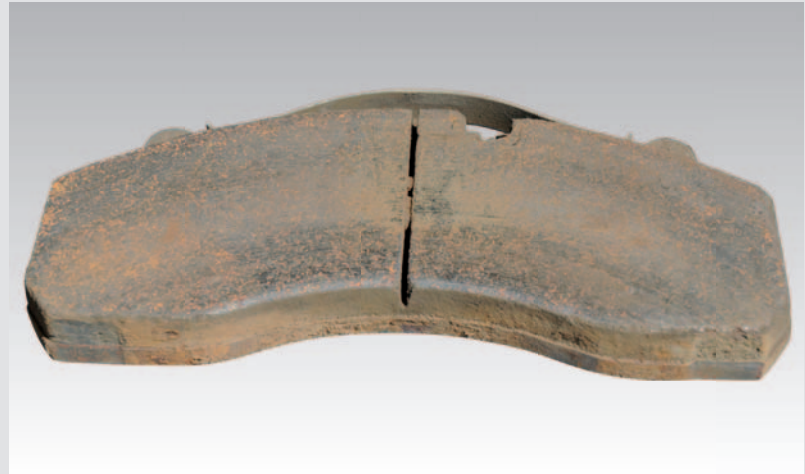
Disc brake pads have exceeded the highest permissible temperature for longer than 15 – 20 minutes.

During this, constituents that contribute significantly towards stability are destroyed.

- Friction material decomposes, breaks off in some places and/or the underlayer and adhesive are damaged. Pad detaches completely; coating peels off. Partial colouring of the backing plate. Friction material has hardened, has a hard ring, reddish brown colouring of the friction material, white ash in some places.

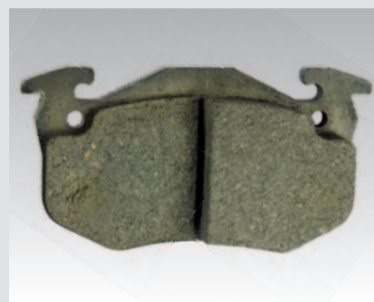
Disc brake pads have been dropped or fitted at a tilt or deformation due to extreme “wobbling” in the brake calliper.

The friction material detaches from the backing plate. Delamination occurs. Disc brake pads are new, separation above the adhesive/underlayer. Damage visible on the backing plate.

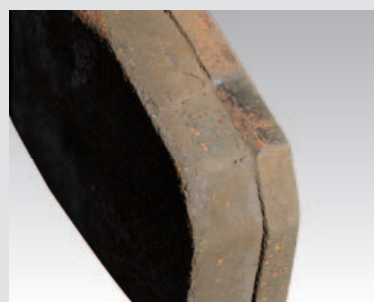
Damage as a result of bending stress visible on the backing plate.

Excessive “wobbling” in the backing plate.

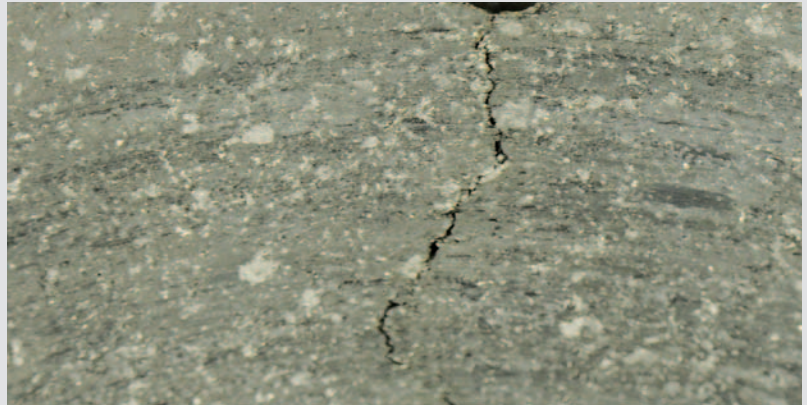
- ▶ Surface cracks can be ignored; they do not pose a safety risk. Even in the case of grooved brake pads, there is no disadvantage regarding pad stability.

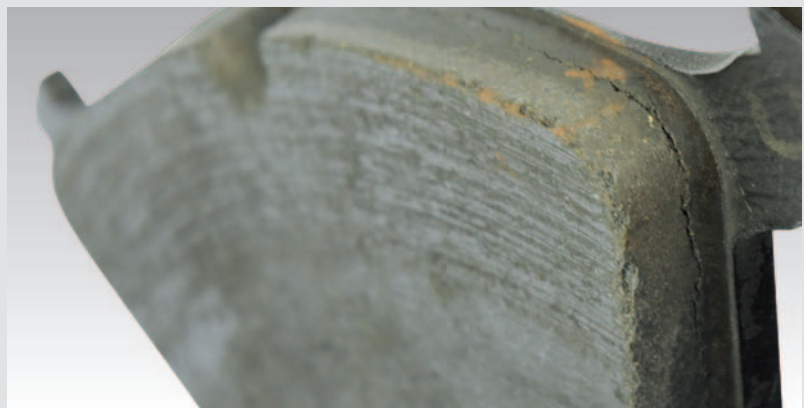
- ▶ Pad with inadmissible deterioration

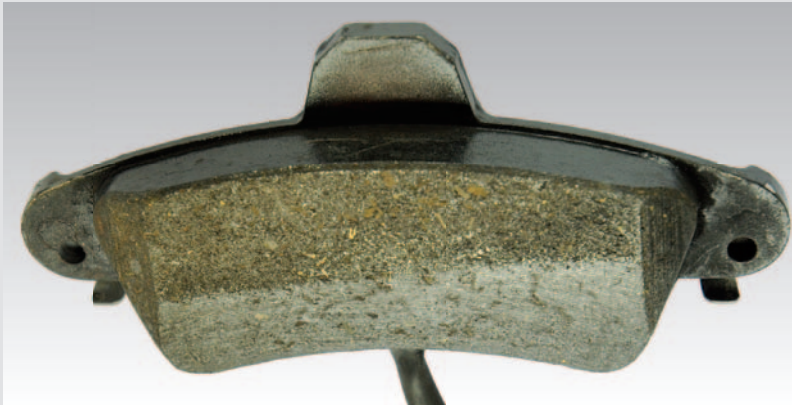
► Pad with inadequate contact pattern

- Worn or incorrect brake disc
- Brake defect / contamination
- Insufficient brake loading
- See also Fitting fault/
Production fault

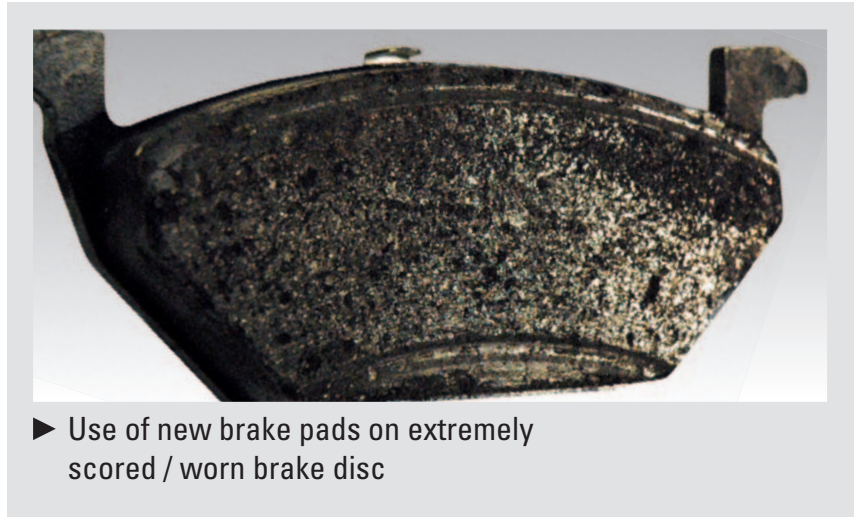
- Destruction of the friction material by mechanical and thermal overload in some places.

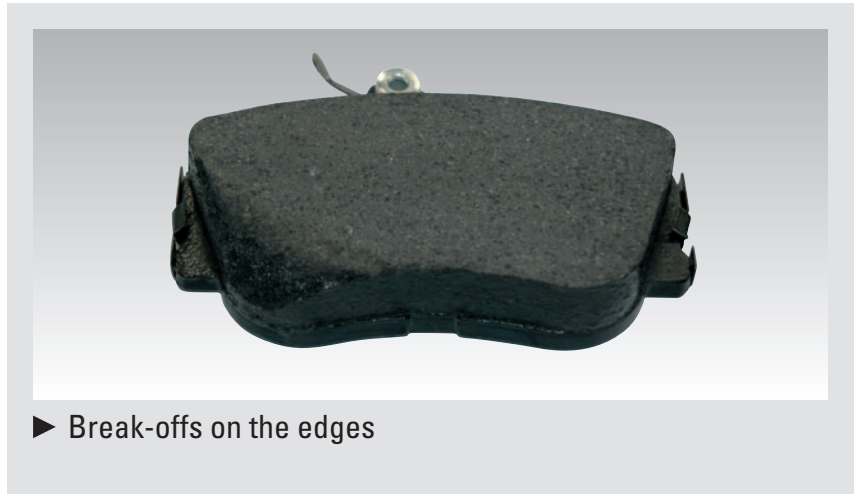
Inadmissible pressing fault

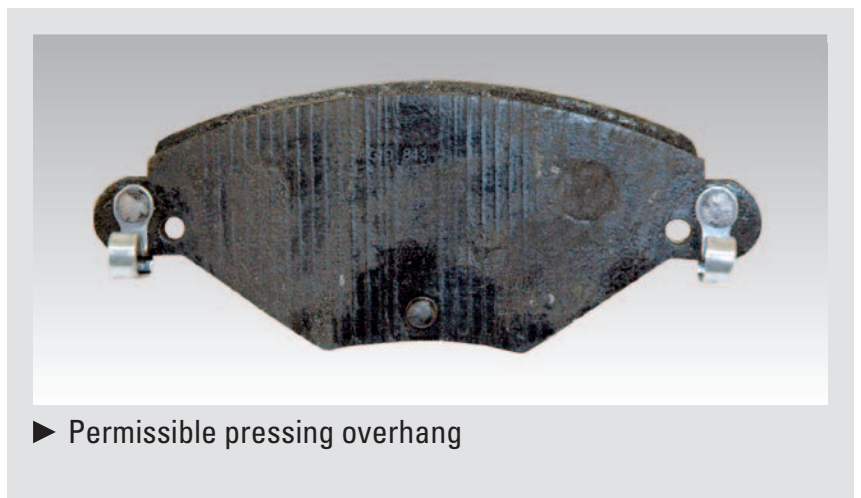
Design-related pressing overhang to completely utilise the friction ring of the brake disc.

Foreign bodies are always inadmissible, inhomogeneous mix proportions are permissible up to a maximum of 5% of the surface.

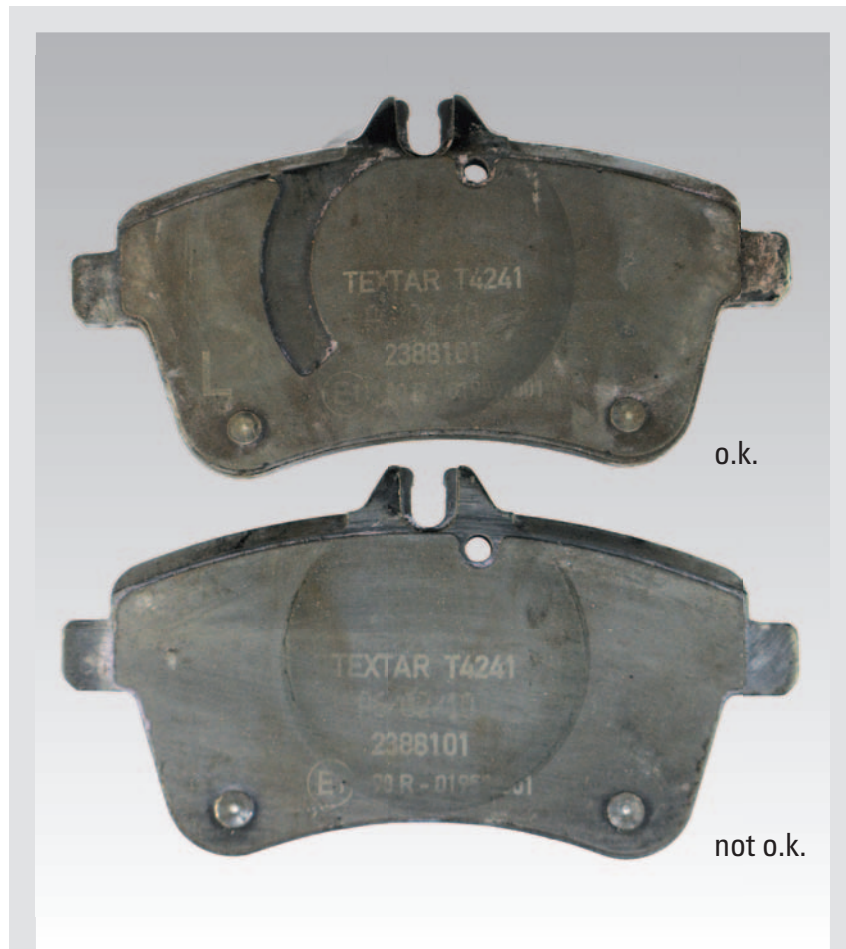
Incorrect fitting position

► Visible imprints / traces on the backing plate

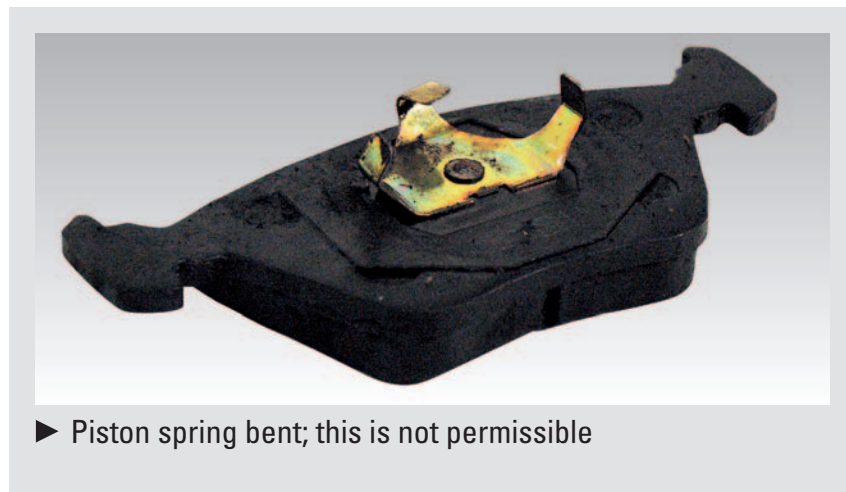
Improper handling
prior to / during fitting

► Piston spring bent; this is not permissible

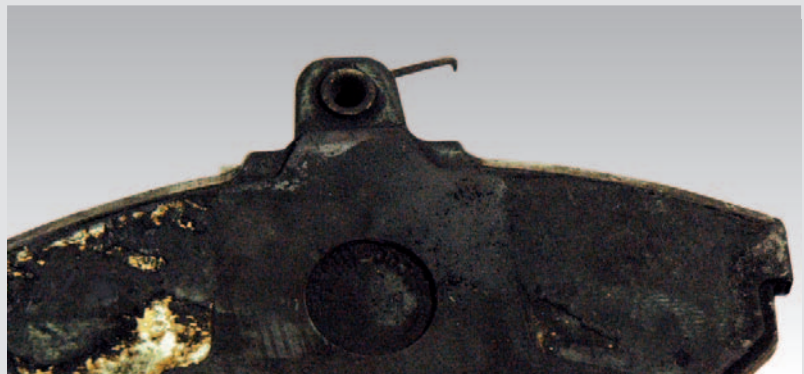
Brake pad fitted improperly

► Hold-down spring broken

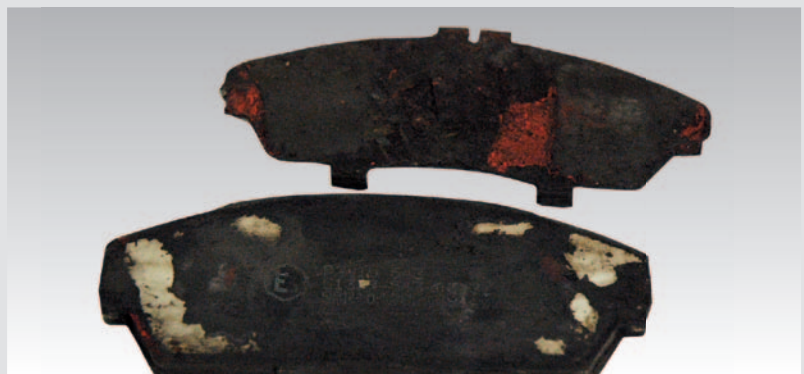
Accessory is subject to use-related wear and, depending on the model type, is included in the scope of supply.

► Clip-on plates worn

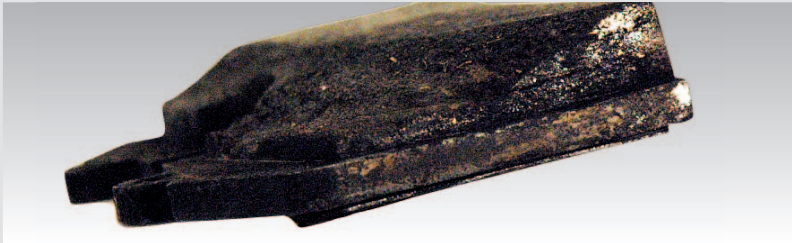
► Obvious damage due to external influence

Brake duct not freed from contamination and corrosion.
Dimensional deviation of backing plate.

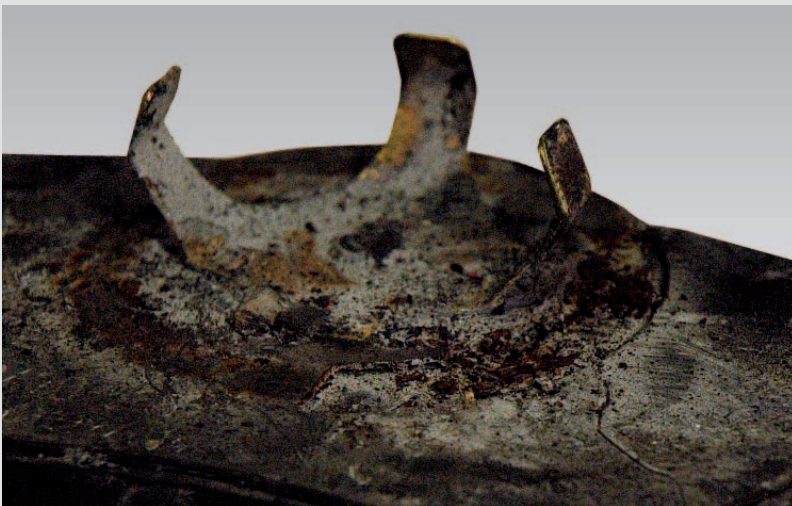
► Cut-out in the damping plate is not functioning due to contamination.

Brake housing not freed from contamination and corrosion;
excessive greasing.

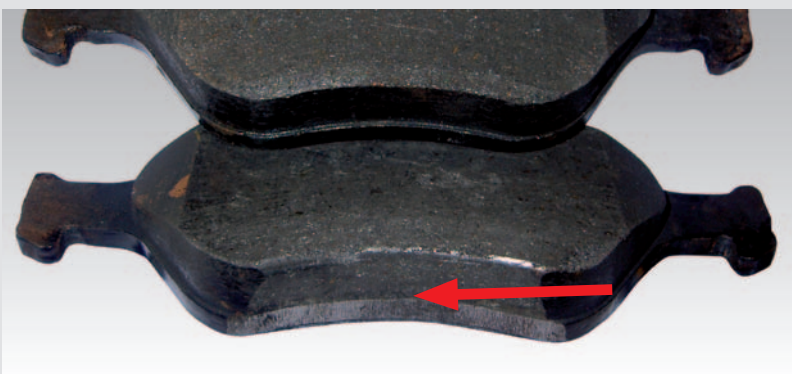
► Improperly changed pad geometry

Inadmissible alteration
during fitting

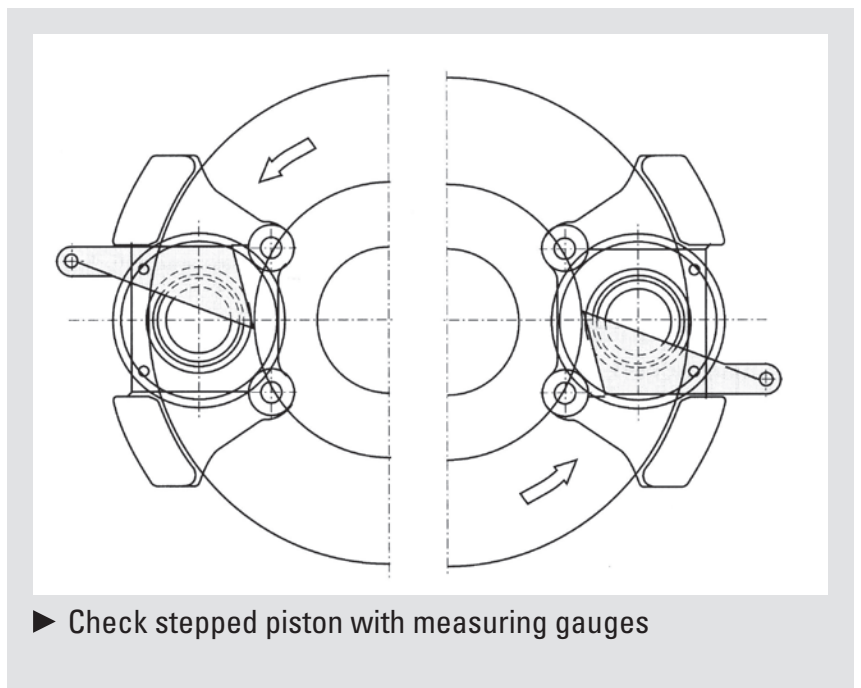
Stepped piston misaligned in the calliper housing.

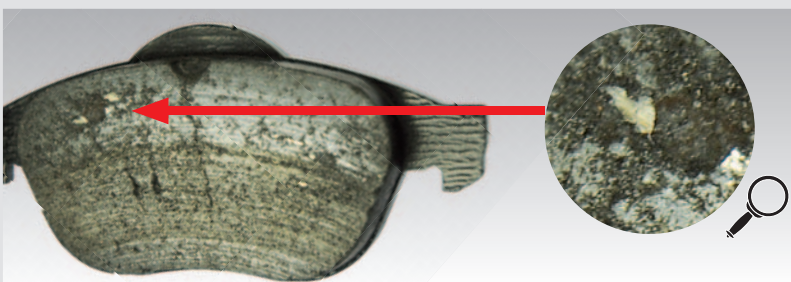
► Residues – metal pick-ups in the pad surface

Material transition from the brake disc onto the brake pad due to, e.g., different loading, climate and/or material incompatibility.

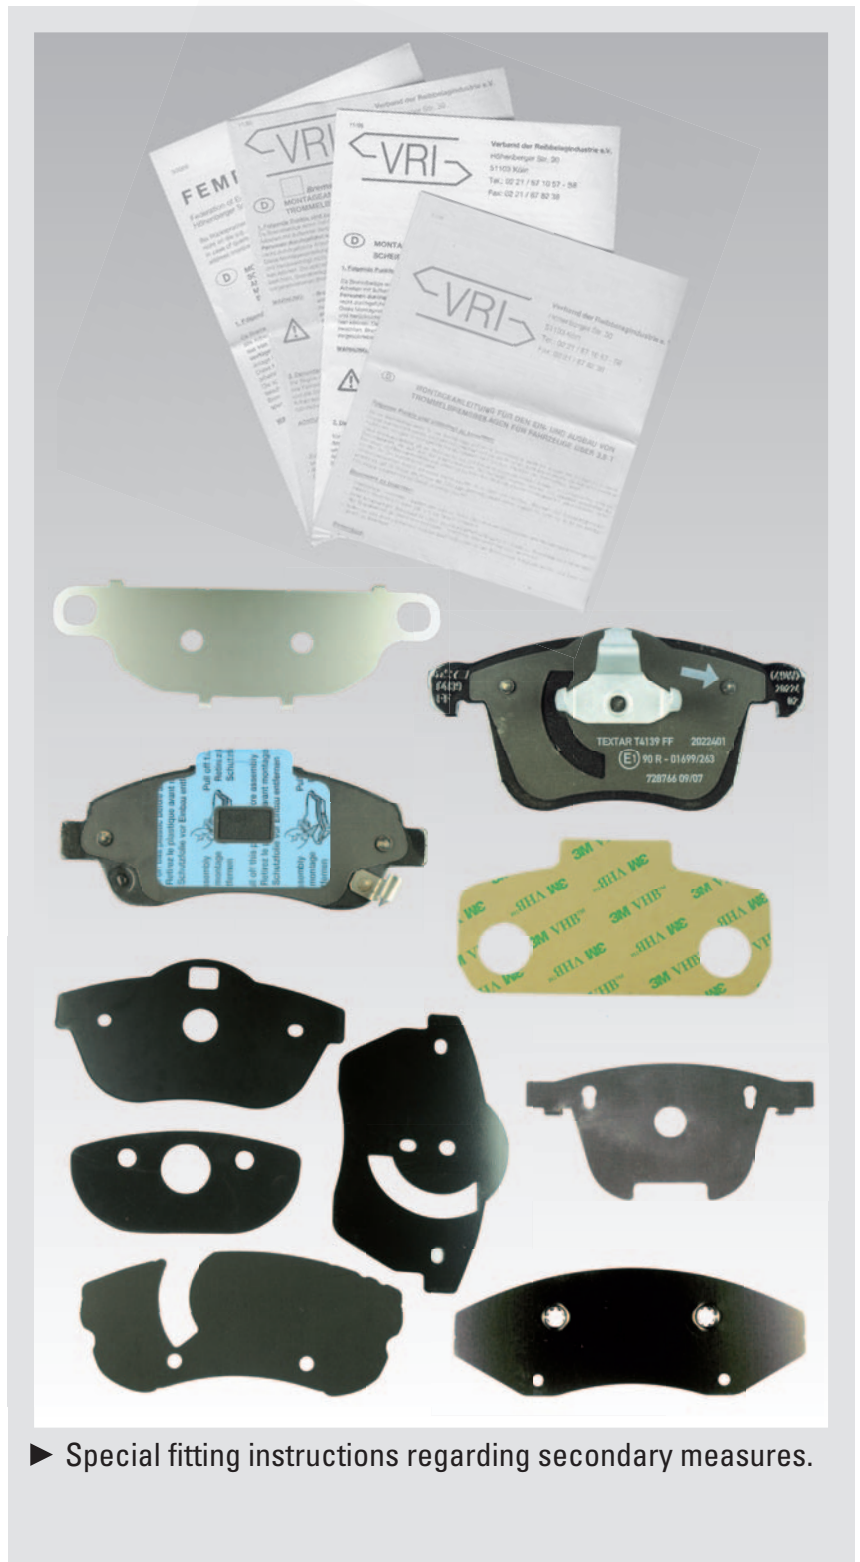
Special fitting instructions regarding secondary measures must be followed to prevent noises, judder phenomena, disc cracks, as well as uneven wear.

► Special fitting instructions regarding secondary measures.

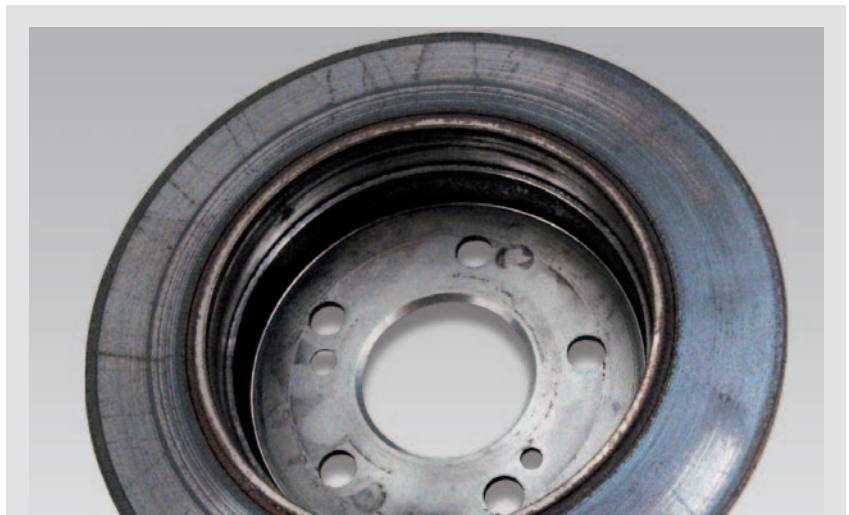
Corrosion, caused by humidity, salt or other environmental factors.

► Brake disc with static spots

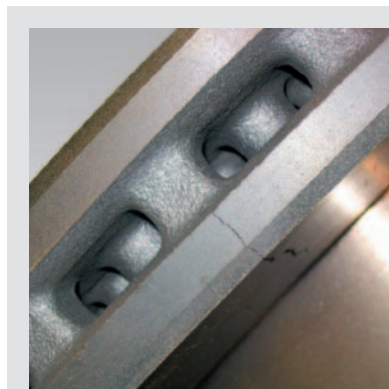
Suddenly occurring, severe signs of judder

► Cracked brake disc

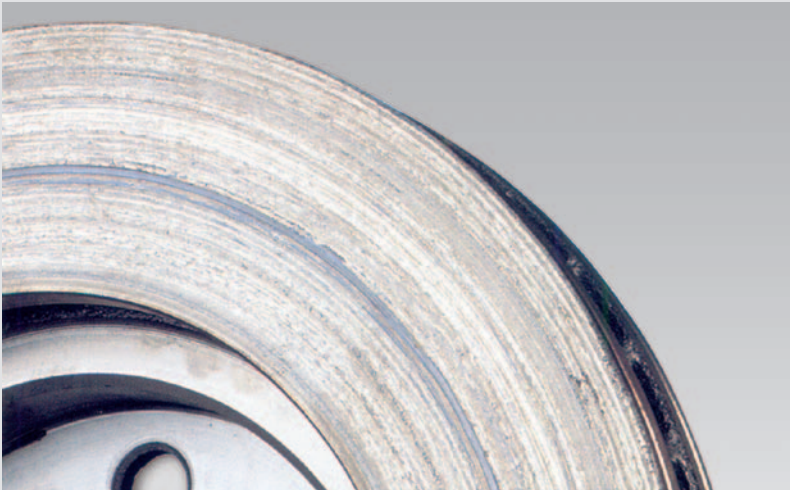
► Brake disc with score marks

Soiling, overload, unsuitable disc and/or brake pad material.

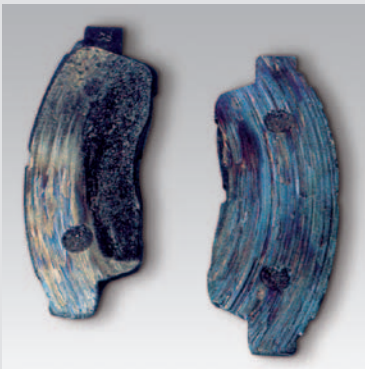
► Friction material worn down to the steel back plate

Brake pads not replaced in time.

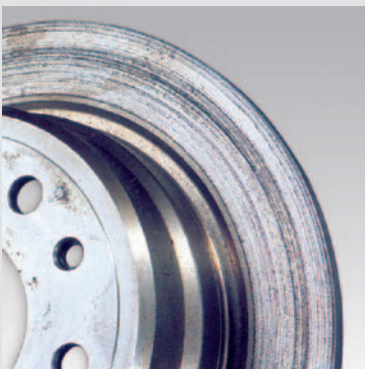
► Brake discs damaged by worn friction material

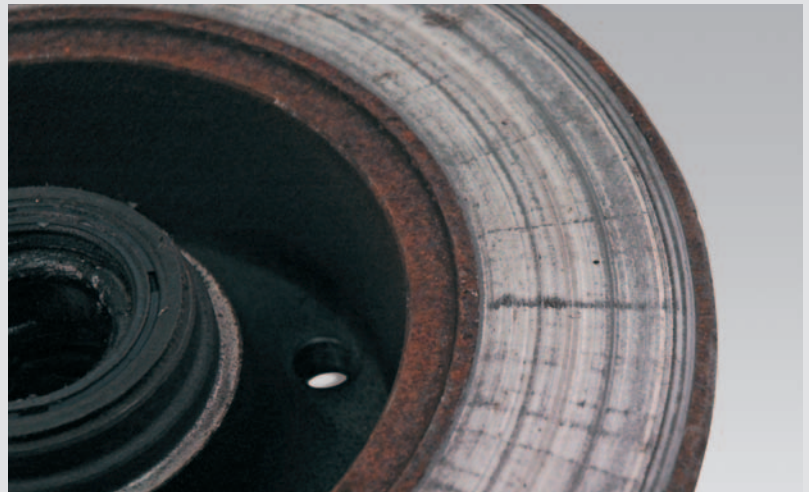
► Corroded brake disc

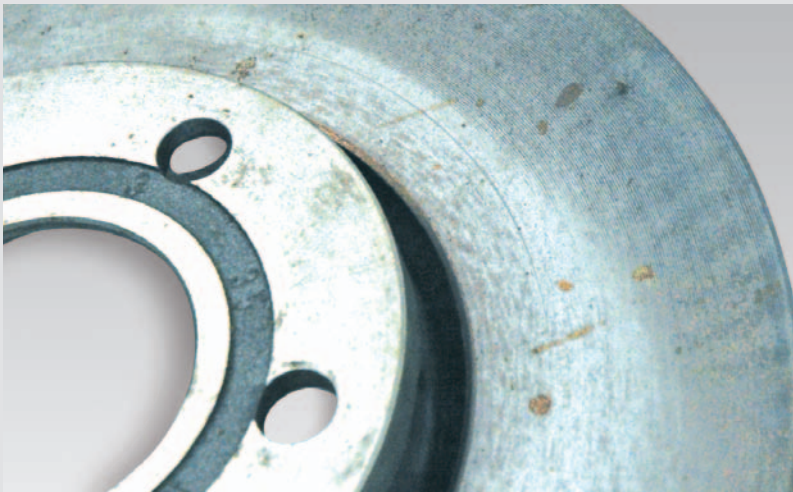
▶ Disc thickness variation

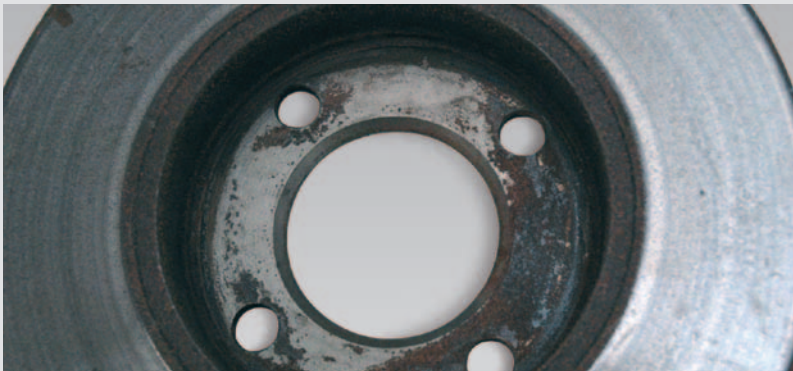
Heavy underlying corrosion at the contact surface

Insufficient cleaning, insufficient contact due to contamination.

Causes disc thickness variations as a result of impermissible radial run-out.

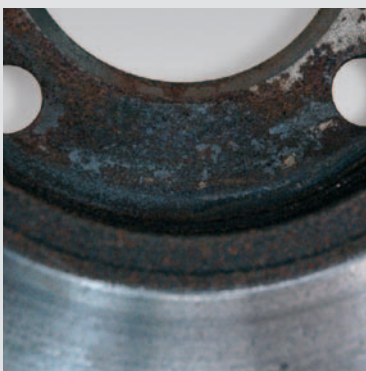
▶ Heavy underlying corrosion
